DIAGNOSIS OF THE EROSION PROCESSES IN THE CARIBBEAN SANDY BEACHES

March 2003

For bibliography purposes this document may be cited as: UNEP/GPA 2003. "*Diagnosis of the Erosion Processes in the Caribbean Sandy Beaches*"; report prepared by Environmental Agency, Ministry of Science, Technology and Environment, Government of Cuba, March.

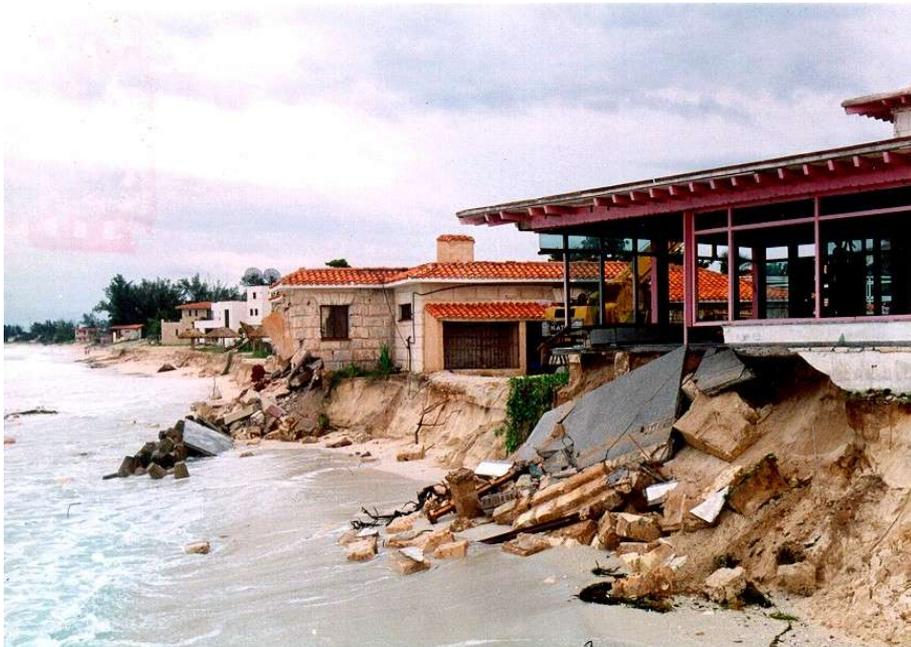
Picture 1: Scarps in the dune, rocky outcrops and fall of facilities

The erosion indications used to evaluate the occurrence of the erosive process were scarps in the dune, rocky outcrops and fall of trees and facilities under the effect of wave. (Picture 1).

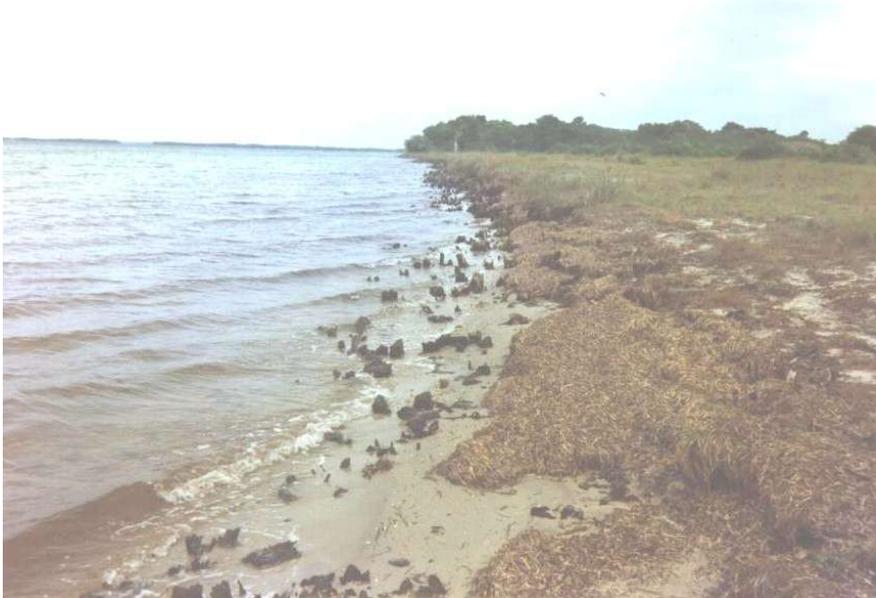
Picture 2: Retreat of the coastline. Las Canas beach, north coast of Pinar del Río.

As an example, in the picture 2 it may be appreciated the presence of relicts of roots of coastal vegetation in the intertidal area and even in the submarine slope of the beach Las Canas, north coast of Pinar del Río, as a consequence of a significant retreat of the coastline. However, man's direct actions have not taken place in this sector.

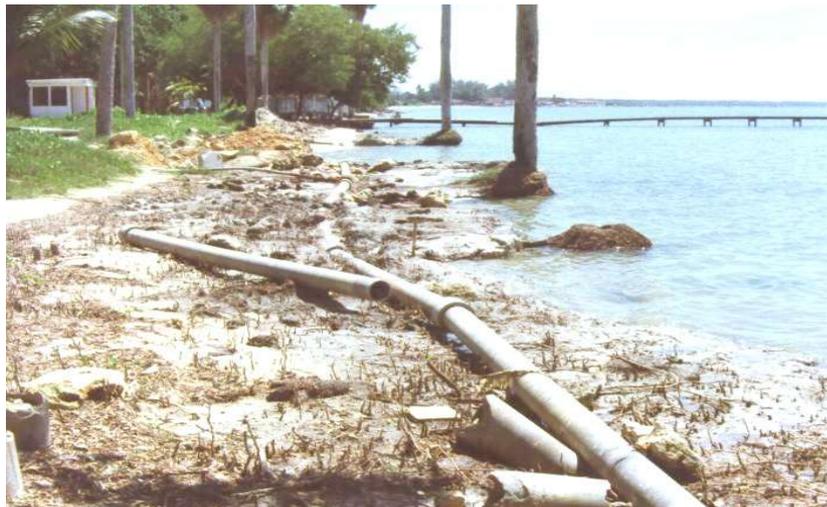
Picture 3. Beach erosion. La Pepilla beach, in the south of Havana.

In the inner beaches south of Havana, it has been possible to appreciate erosion rhythms higher than 2.5 m/year, being noticed the incidence of natural and anthropogenic causes. Maybe the most illustrative example in this process, is that of La Pepilla beach (picture 3), where the sandy fringe practically disappeared as a result of an erosion rhythm of 2.5 m/year (fig 2), causing considerable damages to facilities located near the coast.

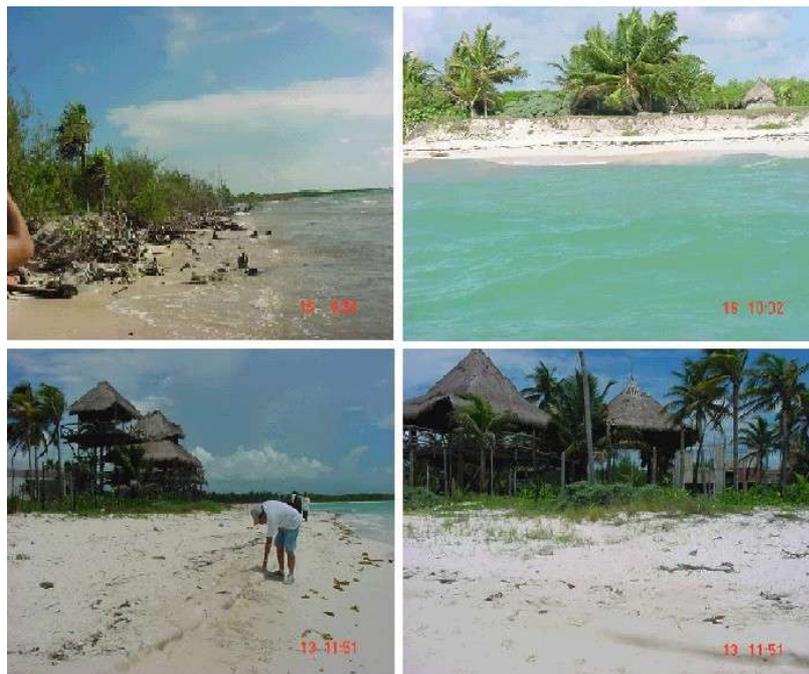
Picture 4. Tres Ríos-Coco Beach coastal sector.

The hotel and services facilities that exist in this tract have been built totally or partially on the coastal dune, eliminating the main sand reserve that the beach possesses for its natural functioning before severe hydrometeorological events.

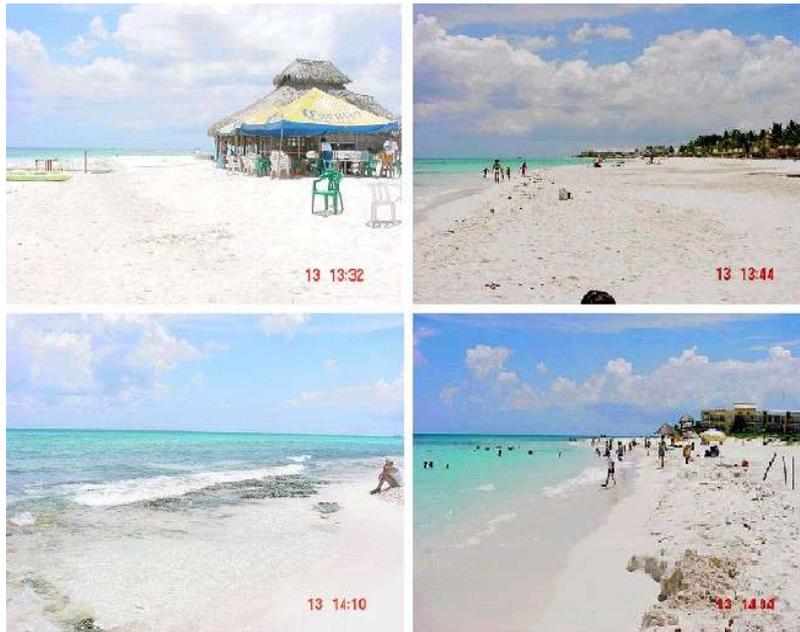
Picture 5. Coco Beach-Porto Real coastal sector.

The second tract, bordering the previous one, extends along 1.3 km, from Coco Beach to Porto Real (Fig. 3), including the beaches Shangrilá, Las Palapas and Tucán (Picture 5, Table 7). This tract presents a wider emerged beach, with around 20-30 m regularly. However, the dune presents little development, also occupied by constructions very near the shore, and erosion scarps 0.30 - 0.40 m high are appreciated on the berm and the beach face.

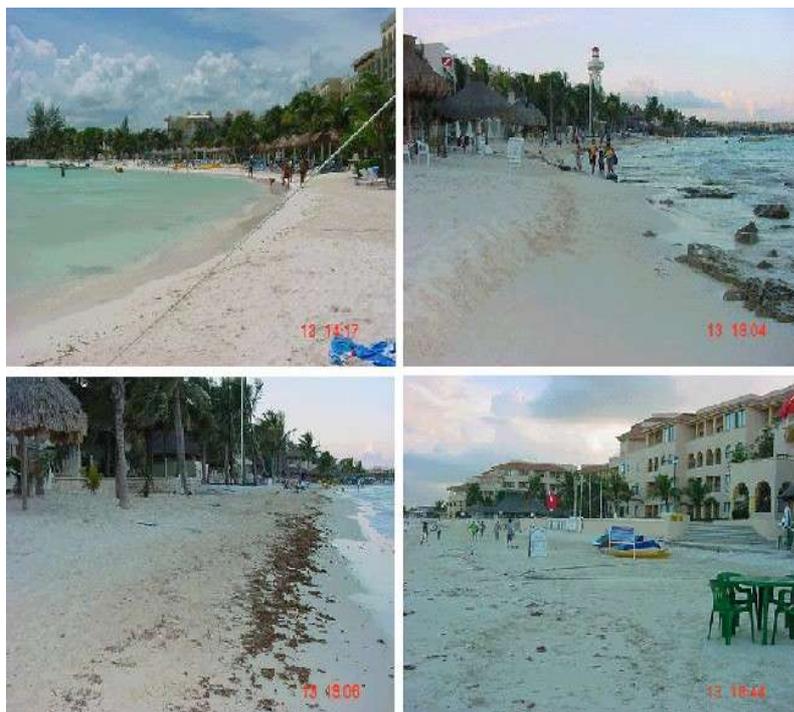
Picture 6. Porto Real-Playacar coastal sector.

The third tract extends from Porto Real to Playacar, with about 4.3 km of longitude (Fig. 3). The hotel area of Playa del Carmen appears here, with a high density of coastal occupation (Picture 6, Table 7), where the coastal dune was totally eliminated. The fringe of emerged beach does not exceed 10 m in width. In several places the wave is impacting directly on the protection walls or the foundations of the facilities, including extensive areas where rock emerges. In various places, groynes and breakwaters have been built with sandtainers, which have been insufficient to control the erosion processes that are happening there.

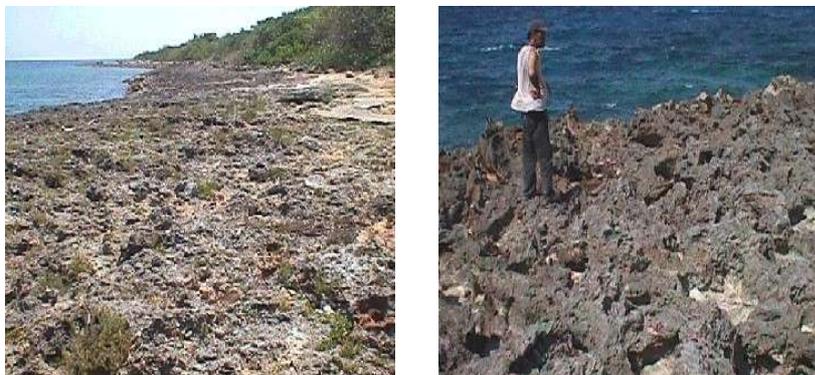
Picture 7. Playacar-Calica coastal sector.

The fourth tract extends from the end of Playacar to Calica, along 4 km (Fig. 3). The main characteristic of this tract is the presence of a high terrace rocky coast, where sand accumulations do not exist on the littoral (Picture 7). This tract includes the shipment area of minerals located in Calica

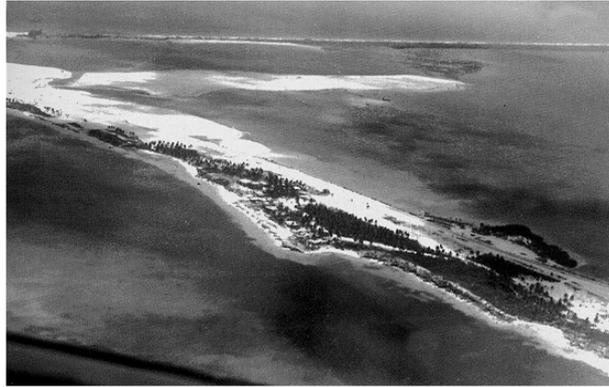
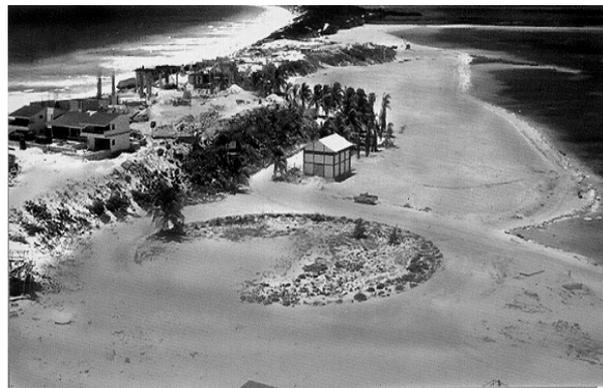
Picture 8. Northeast sector of Cancun barrier island in 1974, at the beginning of the tourist development.

The voluminous deposition of sand gave origin to a beach profile characterized by a potent dune and an extensive berm in the emerged part, and several sandy barriers in the submarine slope, (Picture 8).

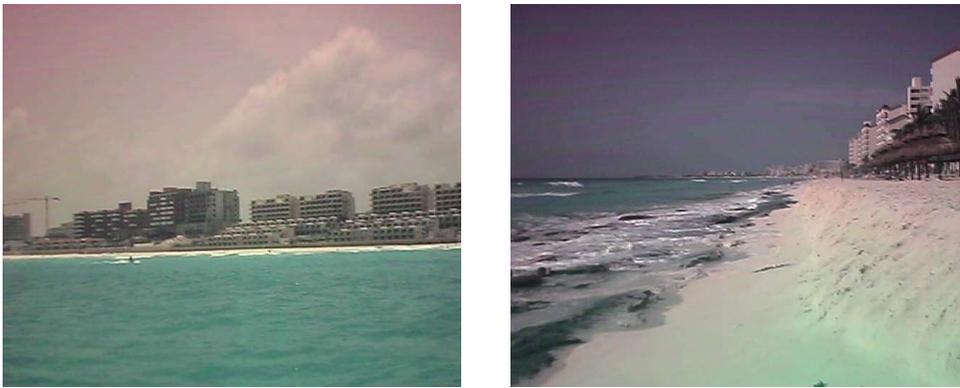
Picture 9. Rocky outcrops and occupation of the dune by tourist facilities.

After several years and in spite of some measures adopted in certain areas, the narrowness of the sun strip, the rocky outcrops and erosion scarps are clear evidences of the erosive tendency in this coast, (picture 9).

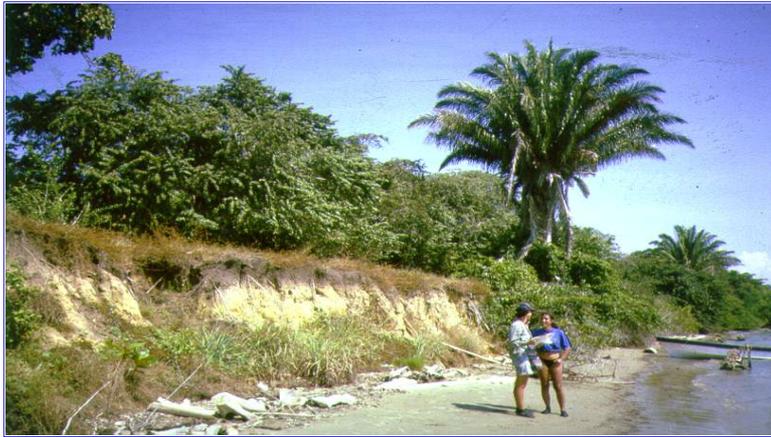
Picture 10. Erosion scarps as a source of sand input to the beaches.

Marine erosion has been the dominant historical tendency along most of the beaches with predominant erosion rhythms between 0.5 and 5 m/year (Picture 10). The variations of the coastline in the last four decades have reached more than a kilometer in some sectors (mainly between the gulfs of Morrosquillo and Urabá), at average retreat speeds up to more than 40 m/year that may be considered exceptionally high, even at global scale.

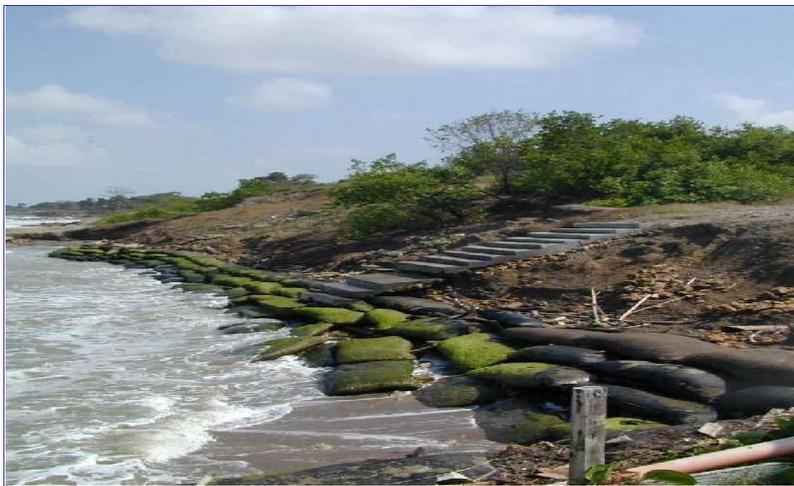
Picture 11. Erosion caused by inadequate use of coastal defenses.

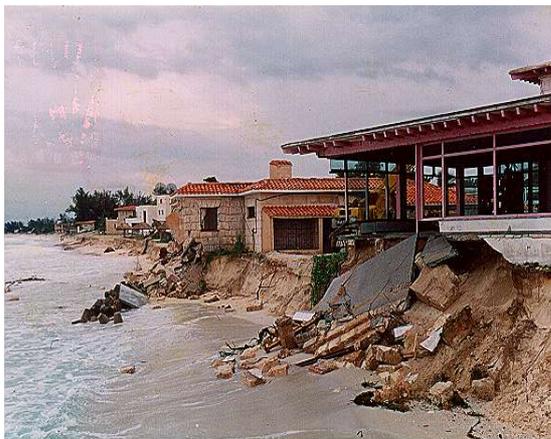
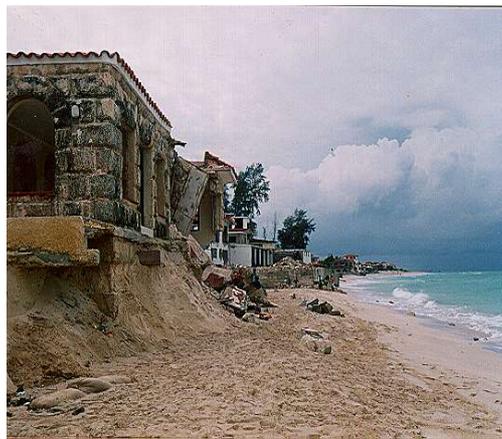
Pictures 12 and 13: Severe impacts to the beach and tourist facilities caused by hurricane Lili at its pass through Cuba in October 1996. Punta Blanca, west sector of Varadero.

However, already in October 1996 the incidence on Varadero of the strong waves associated to hurricanes Josephy and Lili caused serious impacts in the area of Punta Blanca, causing the partial destruction of several tourist facilities (Pictures 12 and 13).

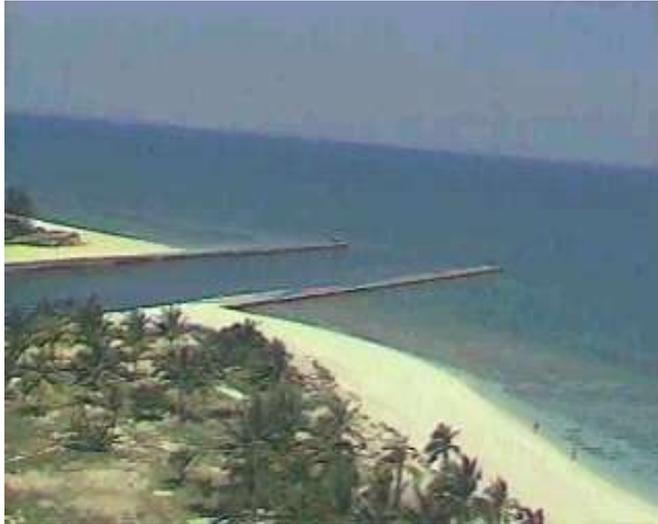
Picture 14. Paso Malo Channel.

At the same time, measurements of sand accumulation are carried out in Paso Malo Channel with the objective of quantifying the material deposited in its interior, (Picture 14).

Keeping in mind that the tendency of sediments transport in the peninsula takes place from east to west, it should be expected that, under strong transport conditions generated by Hurricane Michelle, part of the suspended sand was trapped inside the channel.

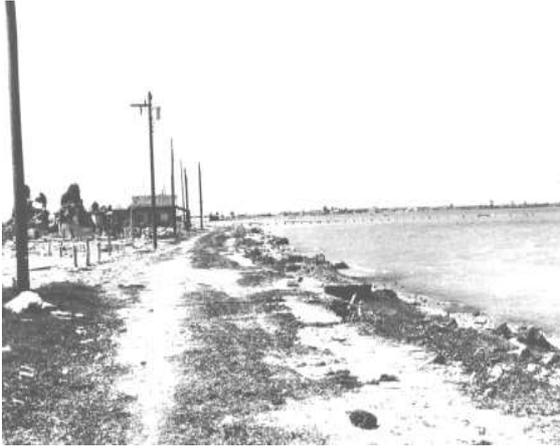
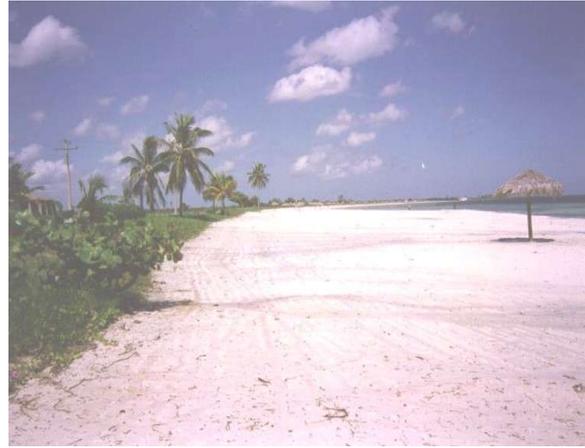
Pictures 15 and 16.
View of the beach before and after the execution of the artificial sand nourishment project.

Pictures 15 and 16 show the changes occurred in El Salto-Ganuza coastal sector with the execution of the project to create the artificial beach.
